CRREL Report 77-10

Ice forces on vertical piles

D.E. Nevel, R.E. Perham and G.B. Hogue

DIRECTORATE OF CIVIL WORKS
OFFICE, CHIEF OF ENGINEERS

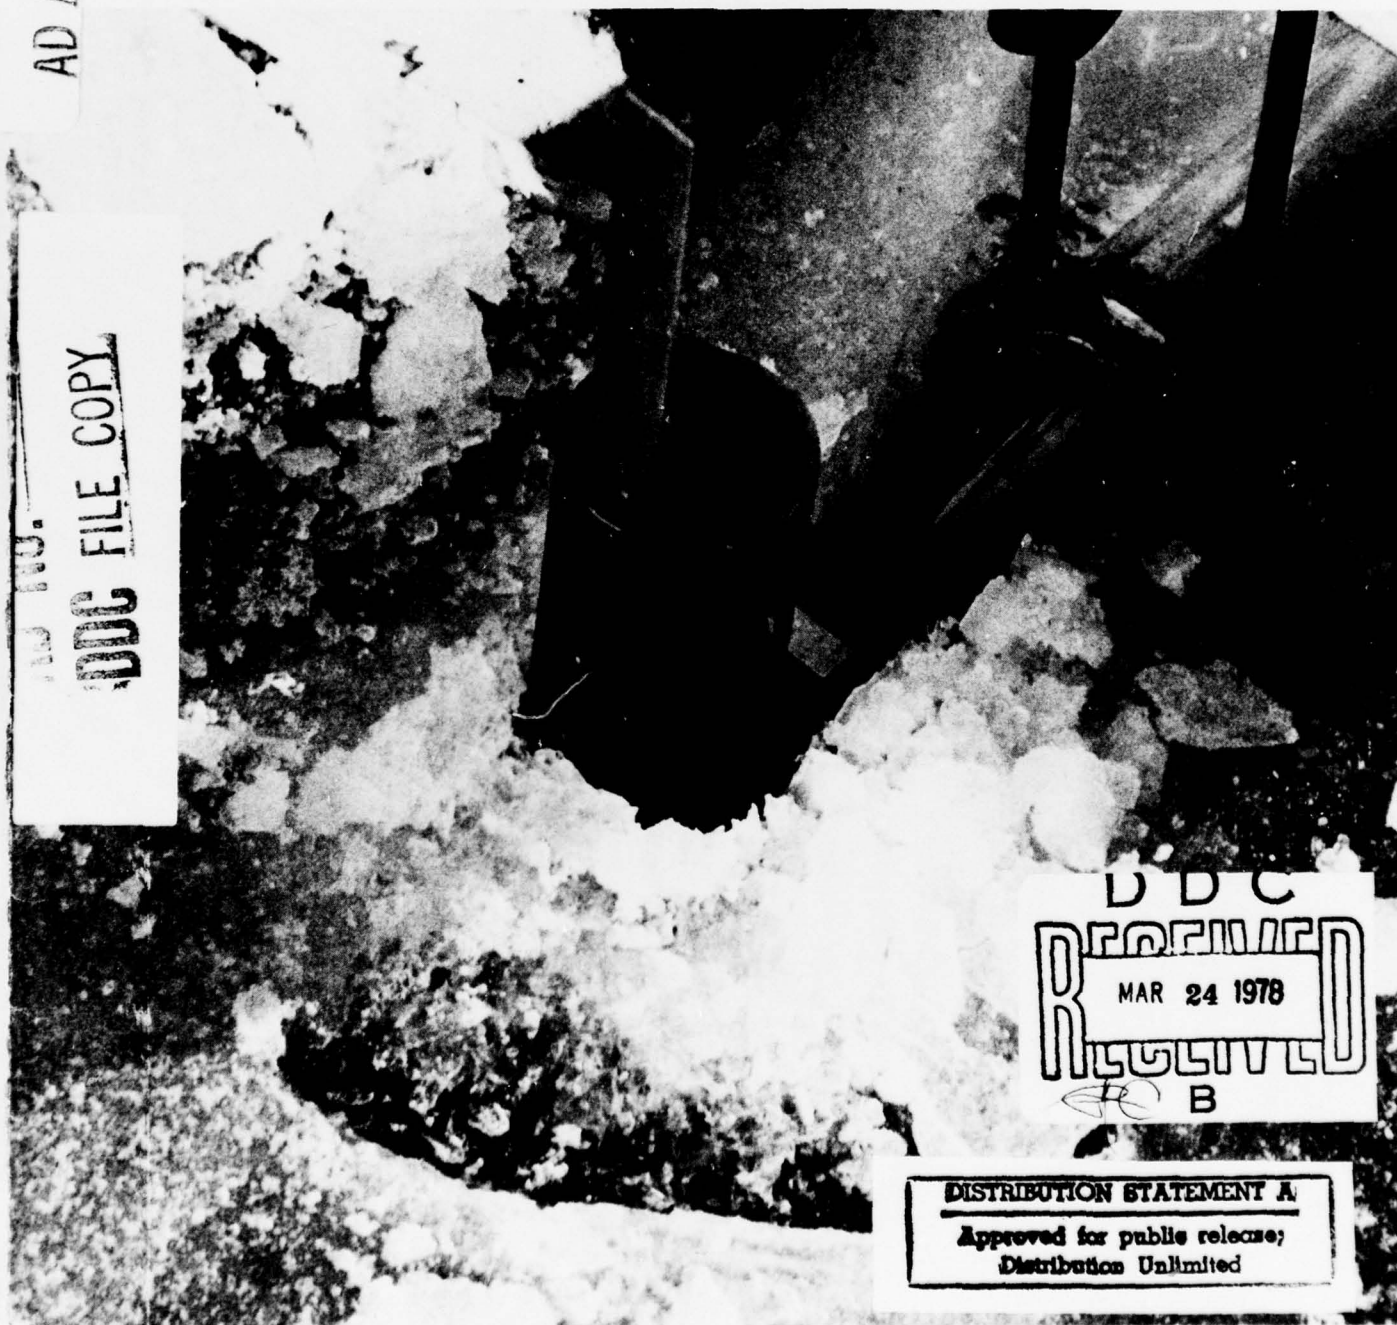
*Cover: Four-inch-wide round pile in natural ice.
(Photograph by CRREL Photo Service.)*

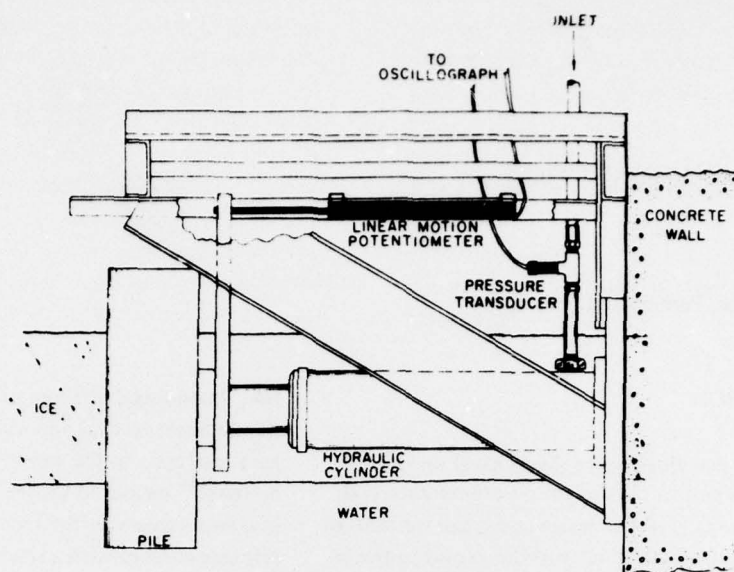
Figure 1. Testing apparatus.

Instead of the ice sheet being pushed into the pile, the pile was pushed into the ice sheet by means of a 50-ton hydraulic cylinder. A 14-x 16-in. aluminum plate was

attached to the base of the cylinder and the simulated pile was located on the rod end as shown in Figure 1. A hole was cut into the ice next to the concrete bearing wall. The outer edge of this hole was cut to conform to the shape of the pile. The apparatus was lowered into the hole and centered on the ice thickness by adjustable cables. The slack between the wall and the ice was taken up by applying oil pressure to the cylinder.

An electric pump was used to store hydraulic oil in a 2½-gal accumulator at pressures up to 6000 psi. This energy was released manually, and quickly, by opening a shutoff valve. The flow passed through adjustable, constant-flow control valves on its way to the hydraulic cylinder. Two control valves assembled in parallel provided a flow range from ½ to 70 gal/min. These flow rates, coupled with the cylinder piston area of 11.05 in.² and a stroke of 13 in., provided tests lasting from about ½ sec to 1 min.

A linear motion potentiometer was mounted parallel to the cylinder and well above it to prevent it from getting wet. The potentiometer directly indicated the pile's displacement and provided a check for uniformity of velocity. A pressure transducer measured the hydraulic oil pressure near the cylinder inlet. Both displacement and pressure were recorded on an oscillograph. Also, the recorder had an automatic, accurate timing marker and an event marker that an observer could operate.

The cylinder rod was found to need an antirotation guide to prevent the tops of the piles from rotating side to side as they moved through the ice. Round piles were provided in diameters of 1.5, 3.0, 4.5, 7.5, 12.6, 18.0 and 36.7 in. Flat piles were provided in widths of 1.5, 3.0, 4.6, 5.5, 8.0, 12.0, 18.0 and 35.9 in. Piles with a 90° angle were provided in widths of 1.5, 3.5 and 4.7 in., while piles with a 45° angle were provided in widths of 1.5, 2.9 and 4.8 in. All piles whose widths were less than 4.5 in. were mounted on an extension plate to prevent the cylinder rod from scraping against the ice. Most of these piles were tested.

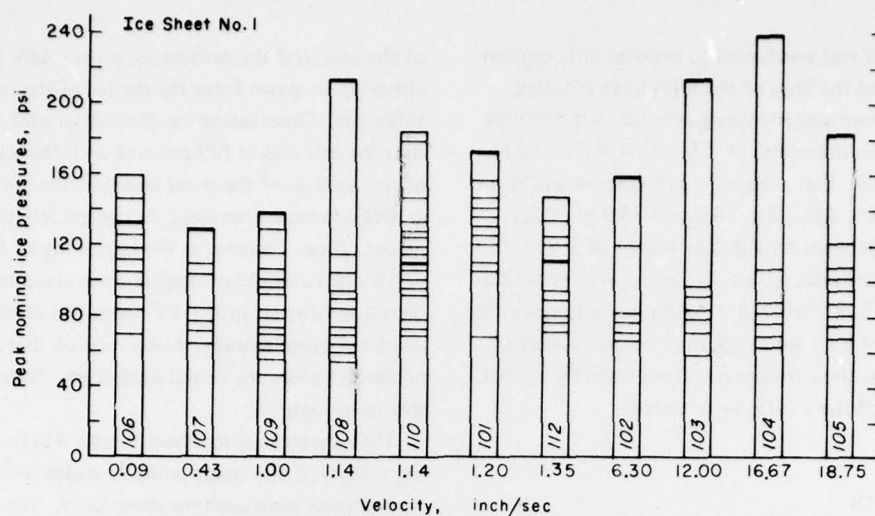
Figure 2. Effect of pile velocity on strength of ice sheet 1. Numbers on bar graphs are test numbers.

The objective of ice sheet 1 tests was to investigate the effect of speed for a 4.5-in. round pile on the strength of the ice. The results from tests 101 to 107 indicate that the speed had no effect within the speed range tested. All these tests, except 106, showed that the initial peak was the maximum peak. The tests that followed were run in an attempt to explain this. Test 108 was started and stopped a number of times, and test 109 was run using the ice sheet as the reaction rather than the concrete wall. In both tests, the initial peak was still the maximum. In test 110, the ice was cut flat rather than conforming to the shape of the circular pile, and test 112 was run with 6 in. of open water followed by 6 in. of ice. Both these tests showed a low initial peak because the piles did not make full contact with the ice initially. Test 111 was run in open water and showed no appreciable force level. The only reasonable explanation for the high initial peak is that the pile was initially in full contact with the ice and broke out a larger piece of ice than any of the succeeding pieces.

In all the tests on ice sheet 1, the failure is best described as *crushing*. Internal cracks developed in front

of the pile, and the broken ice pieces were pushed either up or down from the center of the ice sheet thickness. Observations at the end of each test showed that the pile was in full contact with the ice near the center section of the sheet and that the upper and lower sections were composed of completely broken-up pieces of ice. Usually, at the beginning of the test, radial cracks would propagate from the pile in the direction of push and at 45° from this direction. By using the event marker, it was verified that these cracks occurred before the initial peak load. These results are shown in Figure 2.

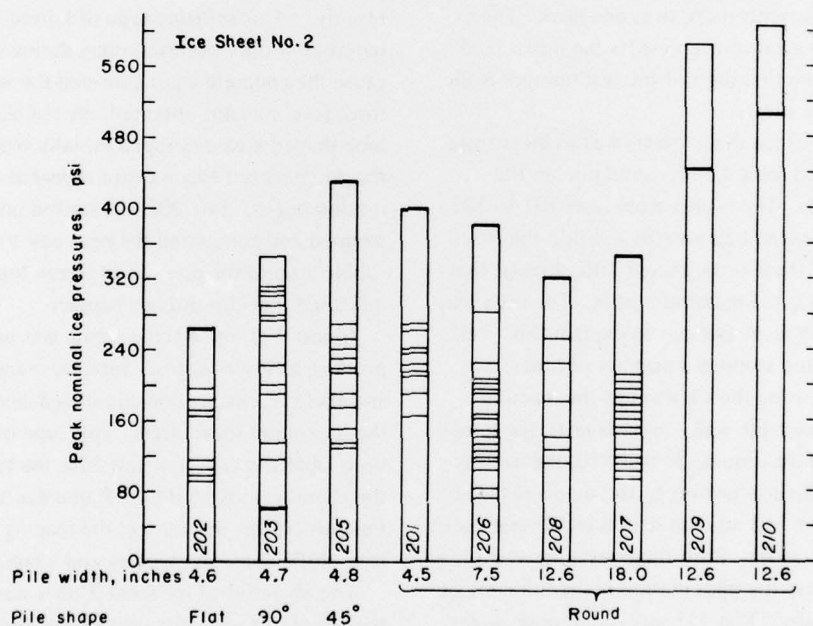
Figure 3. Effect of pile shape and width on strength of ice sheet 2.

The objective of ice sheet 2 tests was to determine the effects of pile shape and pile width on ice strength. Round piles were used for these tests. The results are shown in Figure 3 (tests 201 to 208). In test 203, the ice crushed on one face of the 90° pile, while sliding along the other face. Then the faces reversed their action a number of times, causing a zigzag movement of the pile through the ice sheet. This indicated a high horizontal force on the pile perpendicular to the direction of push.

In test 204 the ice split and moved into a previous test area. This *splitting* type of failure is common in nature, but only occurred once during these tests because the concrete walls confined the ice sheet. The force level was not obtained. In test 205, a crushed lobe-shaped area developed initially from each face of the 45° pile, but this was not repeated after the pile motion began. Test 208 was started one day, then stopped and completed the next day to see if the ice rubble around the pile would freeze together. Results indicated that this did not happen.

In test 209, the electric pump was used directly to produce a very slow test. Internal cracking occurred and these cracks became connected along the lines of the maximum shear stress. This type of failure has been labeled *creep*. For test 210, the temperature of the room was lowered to 0°F one day before the test. For this colder, thicker ice, the loading system did not have sufficient load capacity and a creep failure occurred.

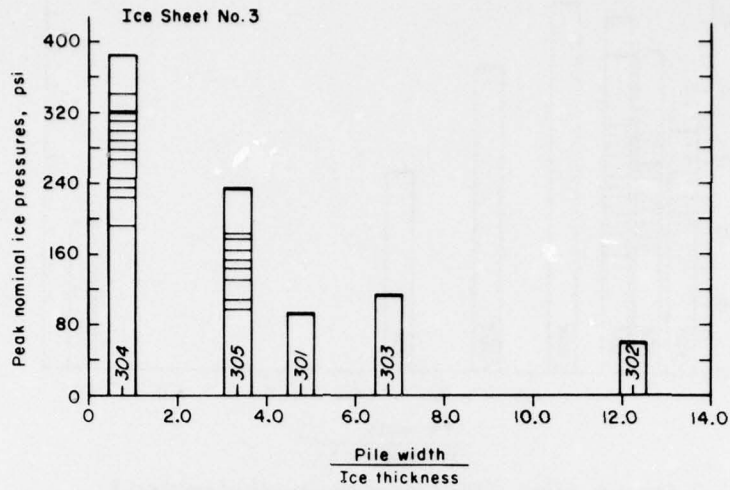
Figure 4. Effect of round pile size on strength of ice sheet 3.

The objective of ice sheet 3 tests was to study further the effect of round pile sizes on ice strength. A thinner sheet was used so that tests of larger piles could be run. The results are shown in Figure 4. Tests 301, 302 and 303 failed because the ice sheet buckled up along a circumferential line about 2 to 3 ft from the pile. There was no vertical movement of the ice at the pile. Test 304 was a crushing failure; in test 305, the ice sheet jumped up as if buckling had started, but the pile crushed its way through the ice.

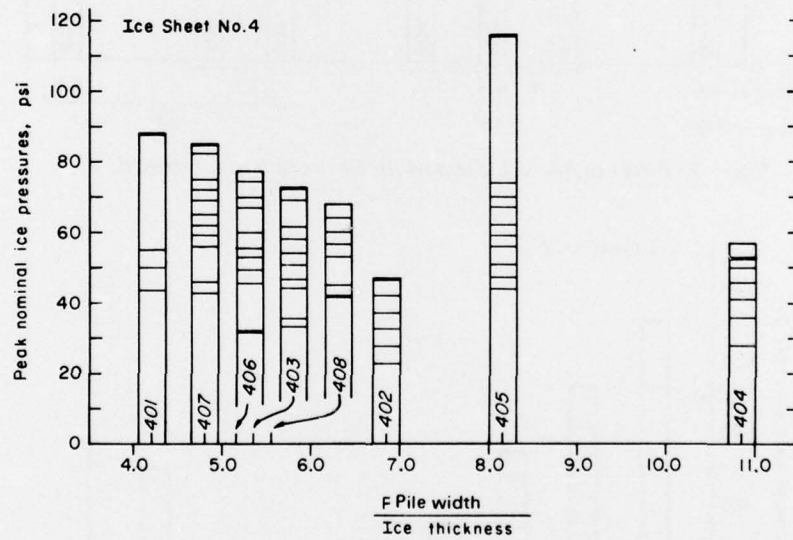
Figure 5. Effect of round pile size on strength of ice sheet 4.

The objective of ice sheet 4 tests was to repeat the results of ice sheet 3 tests. But ice sheet 4 was warmer and softer, and nearly all the failures were crushing. However, in tests 404 and 405, after some crushing had occurred, the ice slid up and over the top of the pile, creating a *bending* type of failure. When this bending failure occurred, many radial cracks developed and the load dropped significantly. The results are shown in Figure 5.

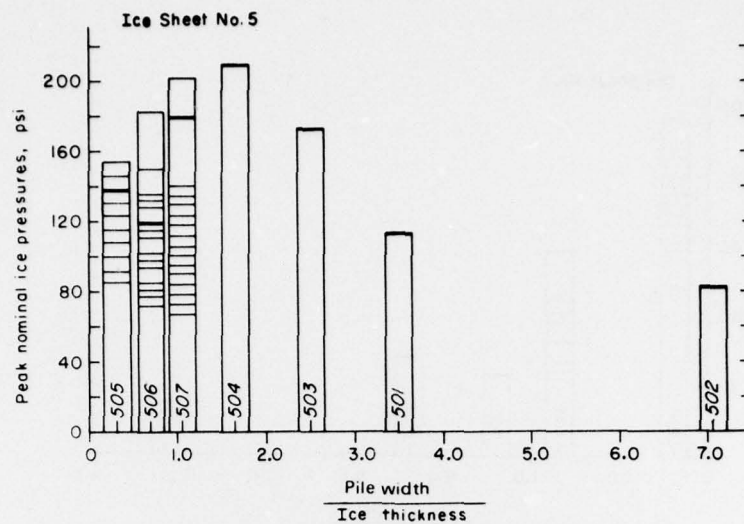
Figure 6. Effect of flat pile size on strength of ice sheet 5.

The objective of ice sheet 5 tests was to study the effect of flat pile sizes on ice strength. The piles in tests 501, 502, 503 and 504 failed by buckling, and the piles in tests 505, 506 and 507 failed by crushing. The buckling failures for flat piles were different from those for round piles. For flat piles, a crack propagated from each corner of the piles in the direction of push, and after traveling a foot or so, they turned outward at 45 $^{\circ}$ angles. This formed a funnel-shaped piece of ice which buckled down in the wider part. Ice sheet 5 had a 1/4-in. surface layer which split off, making it difficult to see the ice cracks underneath. Test results are shown in Figure 6.

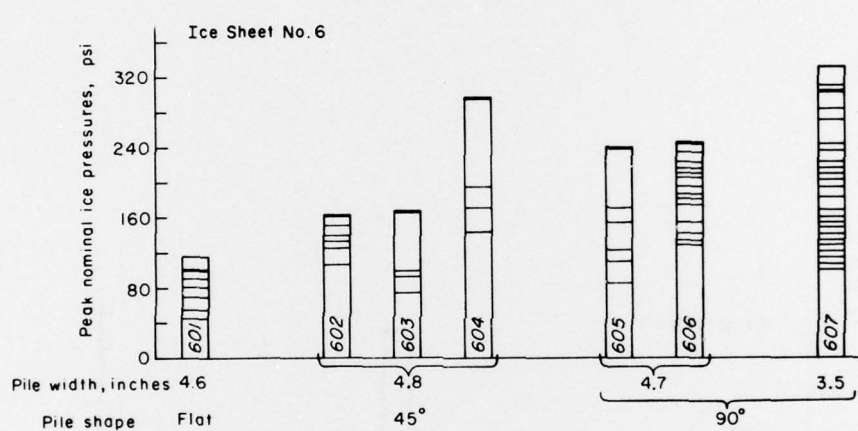
Figure 7. Effect of pile shape and width on strength of ice sheet 6.

The objective of ice sheet 6 tests was to test 45 $^{\circ}$ and 90 $^{\circ}$ piles and to determine how consistent the results were. The results are shown in Figure 7. For the 90 $^{\circ}$ pile the same zigzag failure pattern noted in test 203 occurred. To a lesser extent, it also occurred for the 45 $^{\circ}$ piles. The 1/4-in. surface layer also appeared in ice sheet 6.

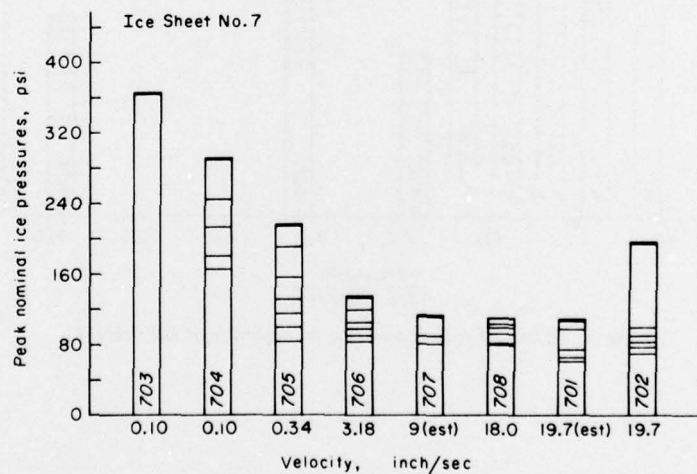
Figure 8. Effect of flat pile velocity on strength of ice sheet 7.

The objective of ice sheet 7 tests was to determine the effect of speed on ice strength of the 5.5-in. flat

pile. In tests 701 and 707, the linear potentiometer cable became disconnected; therefore, the speed was estimated from the flow control valve settings. All the tests were crushing failures except test 703, which was a buckling failure.
